Manhole Inspection Summary

Manhole # S51K__008MH

Location Address: **2700 fait ave**

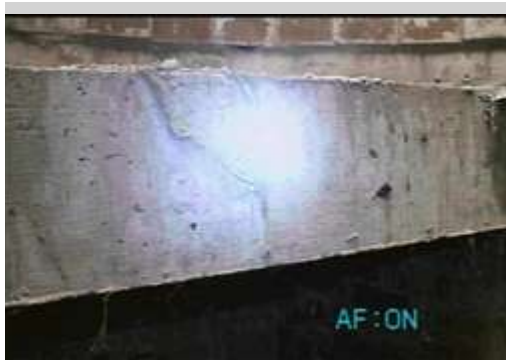
Miscellaneous

Comments **could not see any of pipe at 3 because it has a long channel that curves under a ledge.**

ledge above pipe at 3

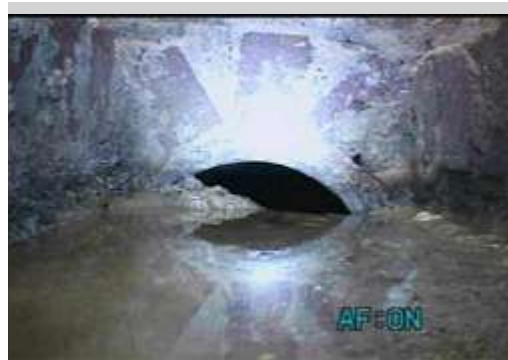
Defect 2

Condition: ☐ Sound ☐ Cracked ☐ Root Intrusion ☐ Deteriorated ☐ Leaks ☒ **Debris**

Channel Debris

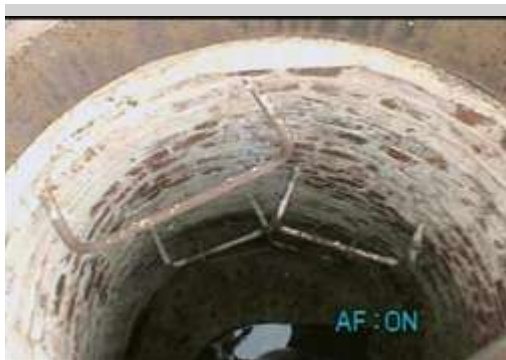
Defect 1

Steps Count: **5** Missing: **0** ☒ **Corroded**

debris & steps

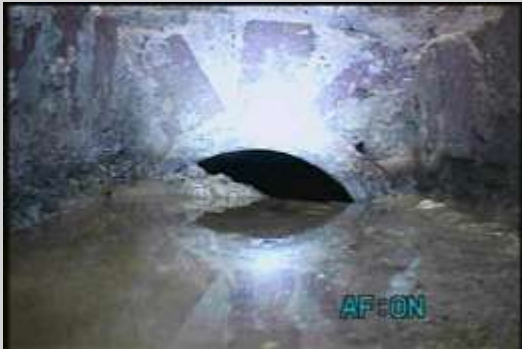
12 O'Clock Outflow

Deposits: ☐ None ☐ Mud ☐ Sludge ☒ **Debris** ☐ Grease

Silt Depth: **6** (in.) Deposits Extent: **Heavy**

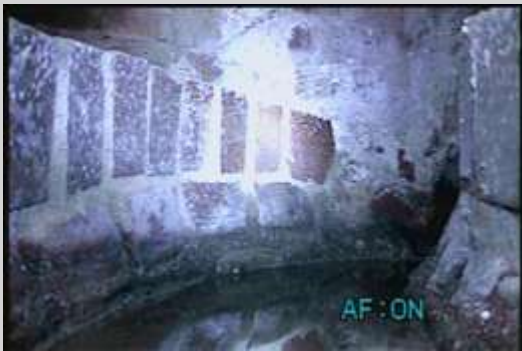
3 O'Clock Inflow

could only get view of channel because of ledge

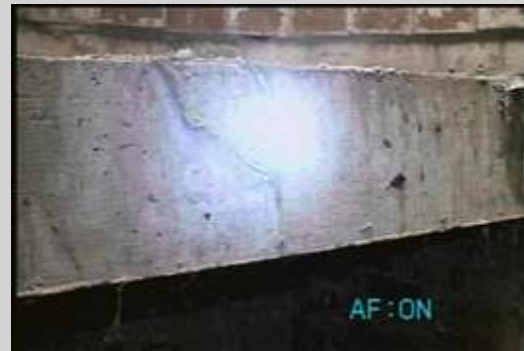
Miscellaneous

ledge above pipe at 3
